Investigation of poor VHF DMR performance of the MD-9600

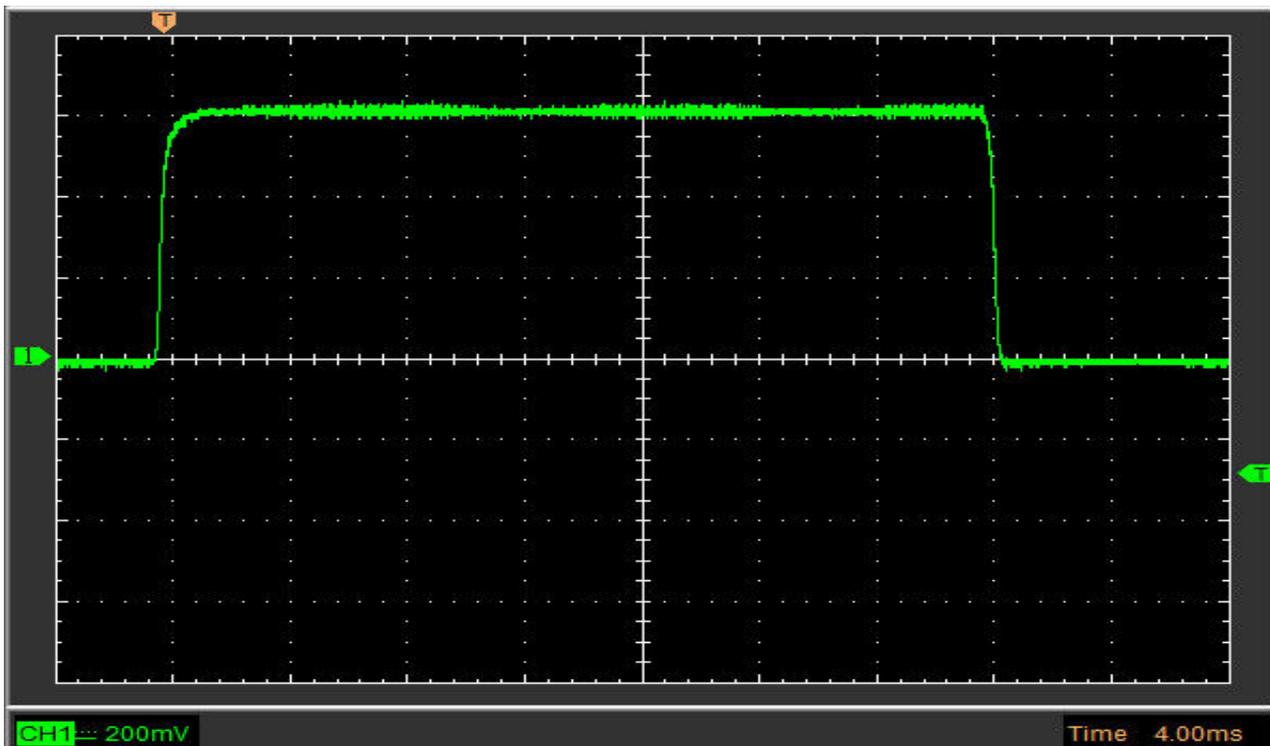
Motorola DM4600 UHF High Power

The DMR burst is allocated 30ms, of which the first and last 1.25mS are allowed for RF ramp up and ramp down. This leaves 27.5mS for the actual data burst.

As can be seen from the reference plot above the DM4600 fits in well with these timings. The horizontal timebase is 4mS per division so it can be seen that total burst length is about 28.5mS with the central 27.5mS being very flat.

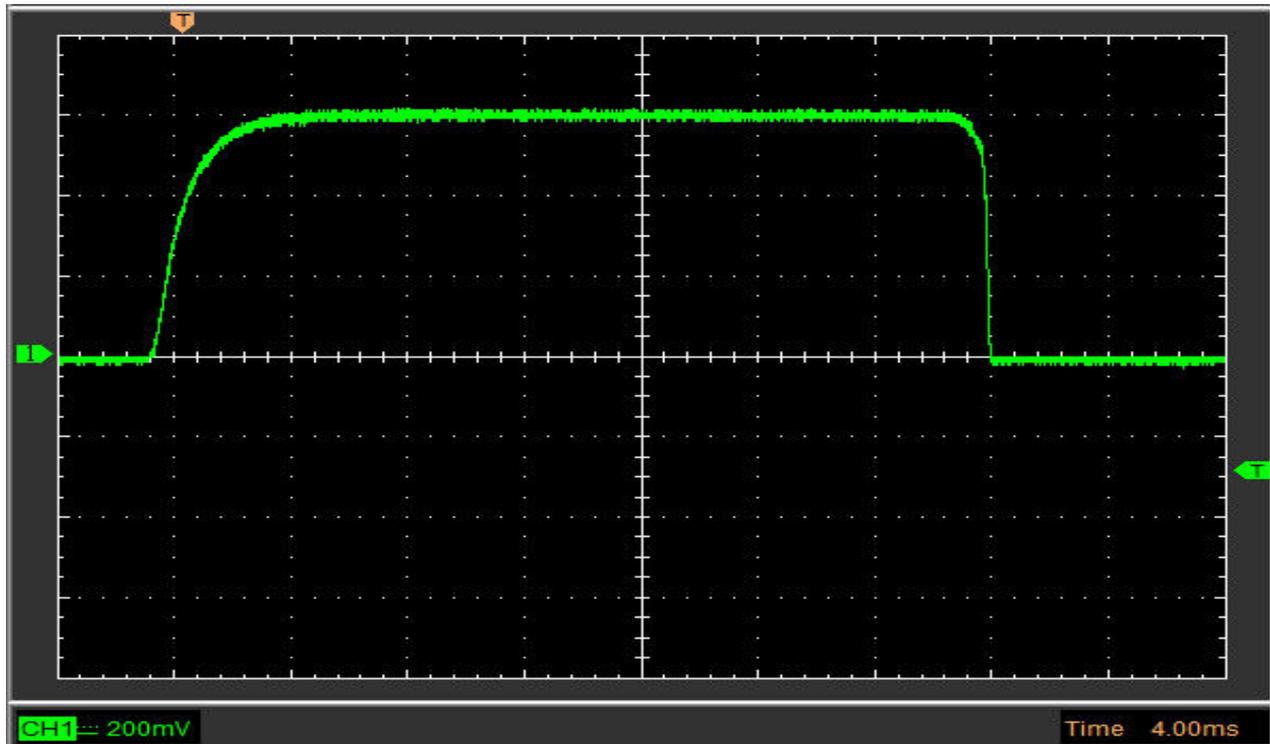
MD-9600 UHF High Power

As can be seen the rise-time of the RF output is significant longer than the Motorola radio. Only about 24mS of the burst are at full power. During the first 3.5mS of the data period the RF amplitude is still increasing. This is not ideal but in most cases would probably not cause a problem with reception. The same test was then done at low power.

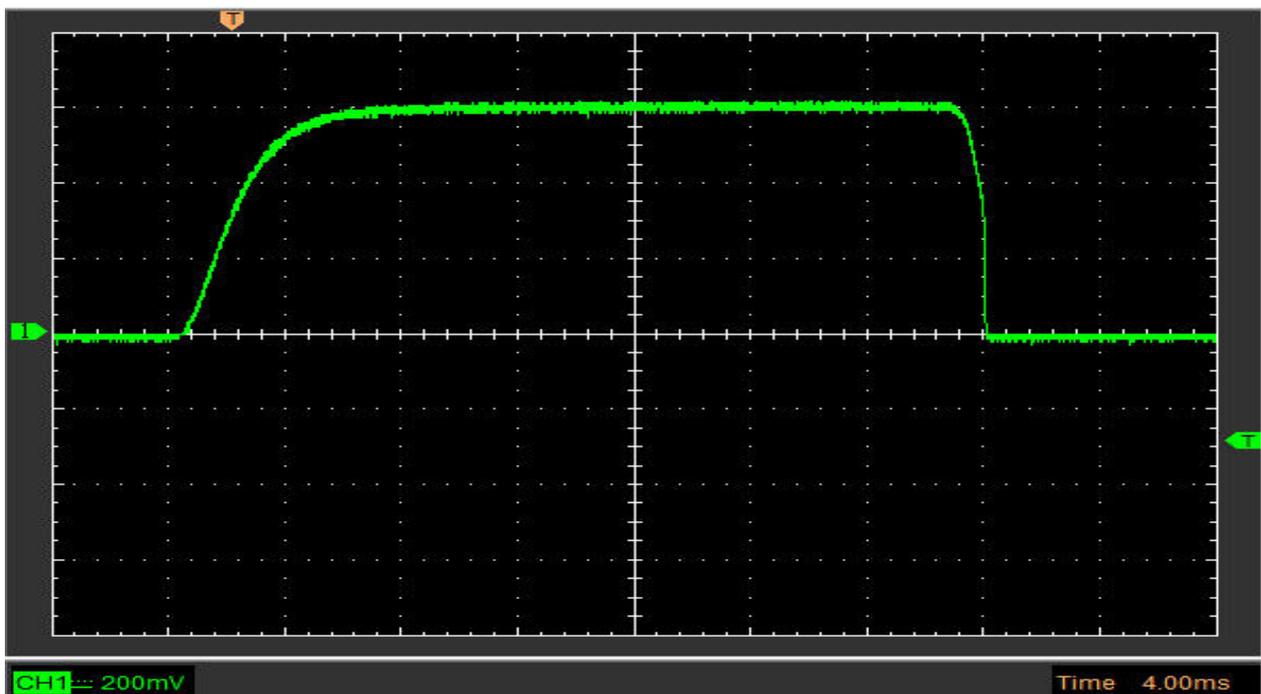
MD-9600 UHF Low Power

As can be seen at low power the rise-time is longer still. Only about 20mS of the burst are at full

power. During the remaining 7.5ms the RF power is ramping up from zero. I would expect this to be causing data errors in transmissions although it has not been reported. This may be due to people assuming the low power setting is the primary cause. I then repeated the test at VHF high power.

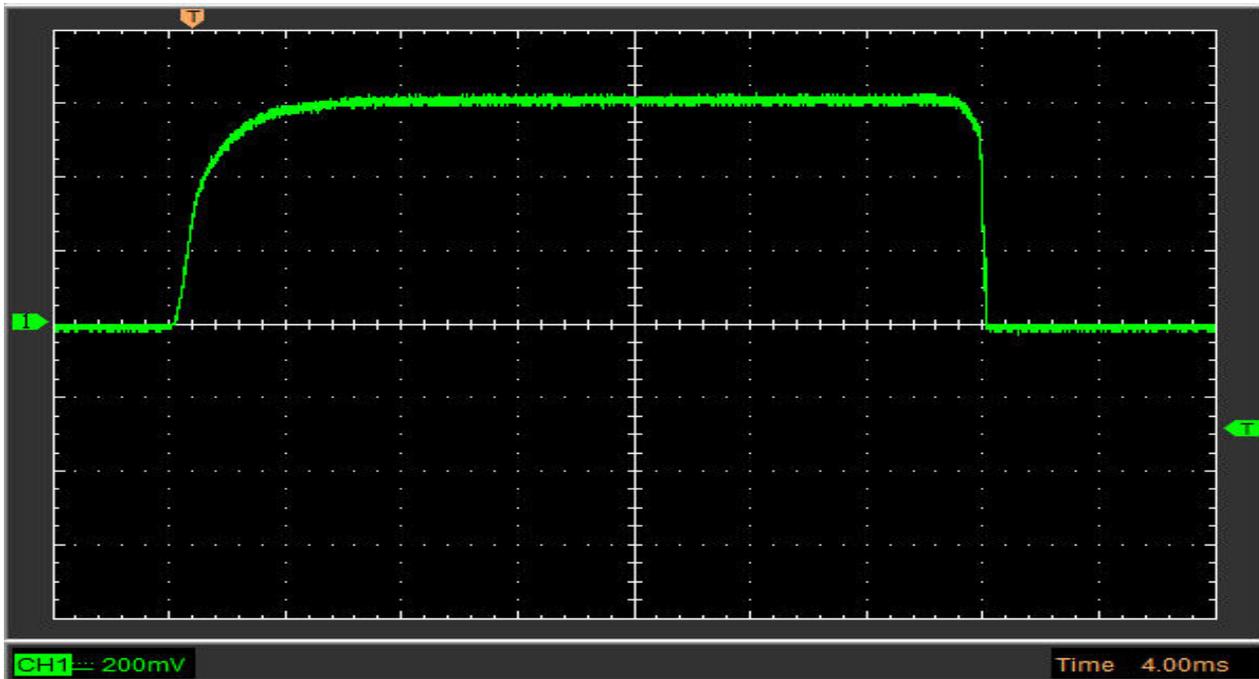
MD-9600 VHF High Power.

The rise-time for VHF High power is similar to that for UHF but the starting time for the RF burst appears to be about 1mS later. The total time for the whole burst is less than 28mS. This, coupled with the slow rise-time means that the first few ms of the burst are at very low or maybe even zero power levels. This would certainly be noticeable as a poor BER on the transmission. I then repeated the test at VHF Low power which is where people have reported significant BER increases.

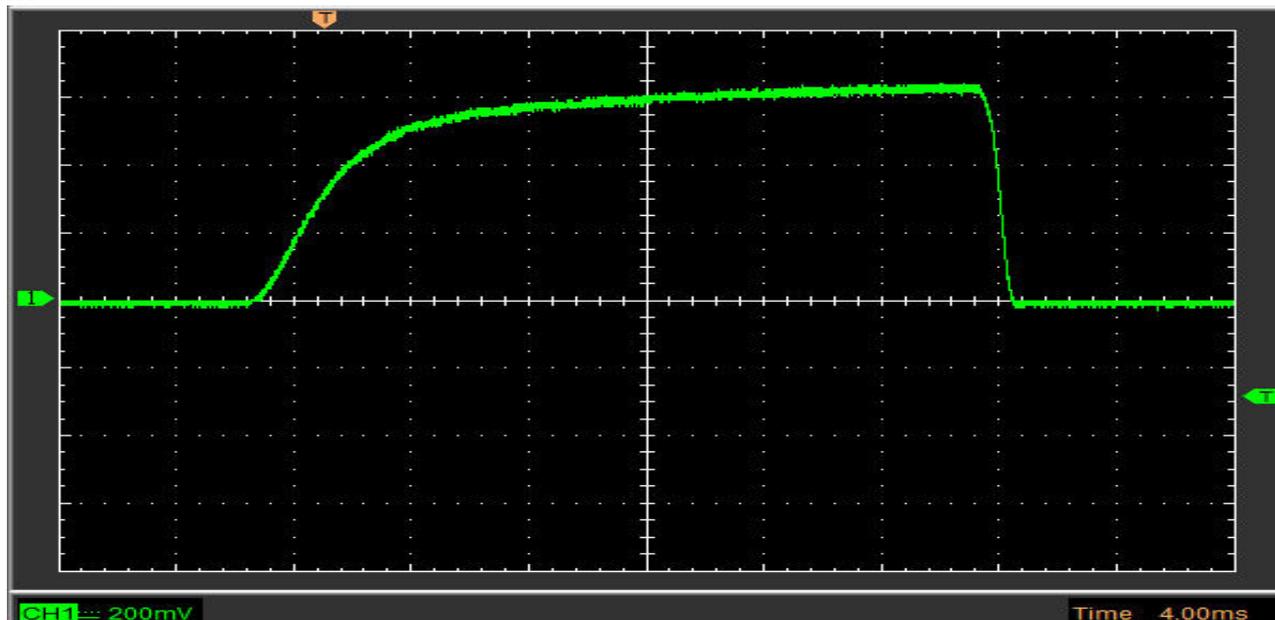
MD-9600 VHF Low Power

This plot was so poor that I was sure I had made an error somewhere so I repeated the previous tests

to make sure nothing had changed. It had not. The envelope of the MD-9600 on VHF Low power was really this bad.

The most significant point is that the length of the whole burst from zero power to zero power was only about 25mS. (just over six horizontal divisions instead of the previous 7 divisions). That means that at least 2.5mS of the data burst were not being transmitted at all. Also the rise-time is extremely slow resulting in the whole burst having a rising slope to it.

This RF envelope would defiantly result in a significantly high receive BER as is being reported by users.

Repeating the same test at the Mid-low and Mid-hi power settings showed the same shortened burst. This confirms peoples reports that only high power VHF works properly.

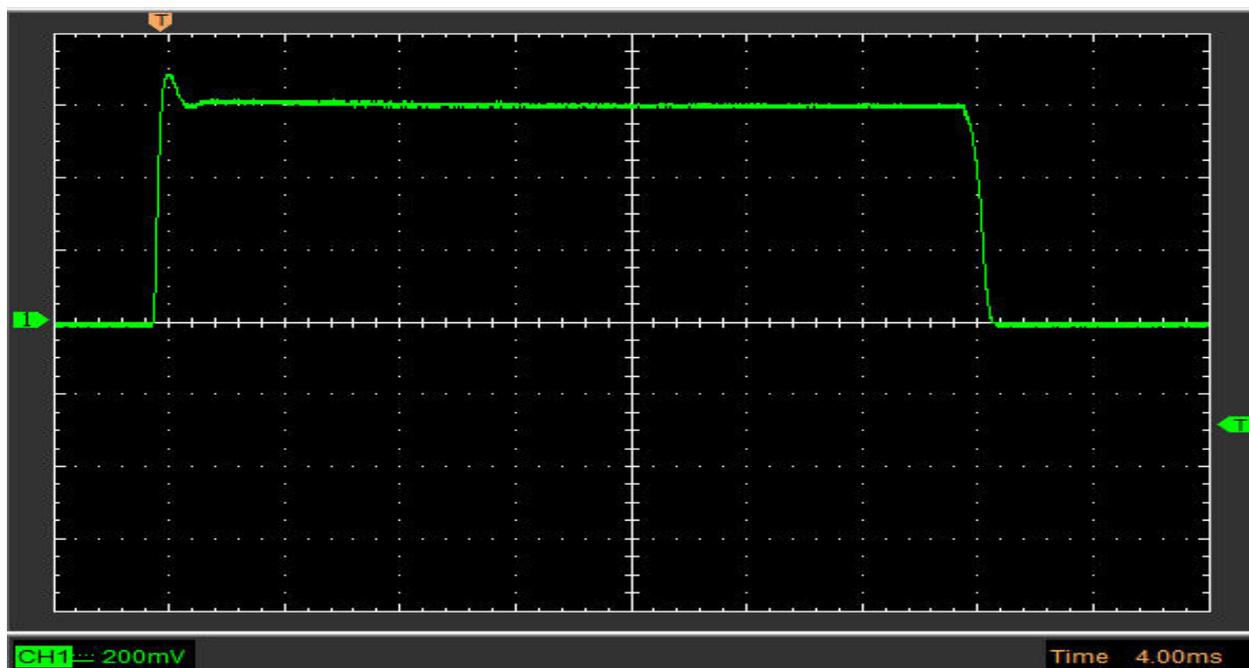
MD-380 UHF High Power

This shows really fast rise and fall times, in fact the rise time is a bit too fast giving a little overshoot. However this wouldn't cause any noticeable problems. So TYT can produce a good radio.
